London based Data Centre, Canary Wharf

PROJECT DETAILS

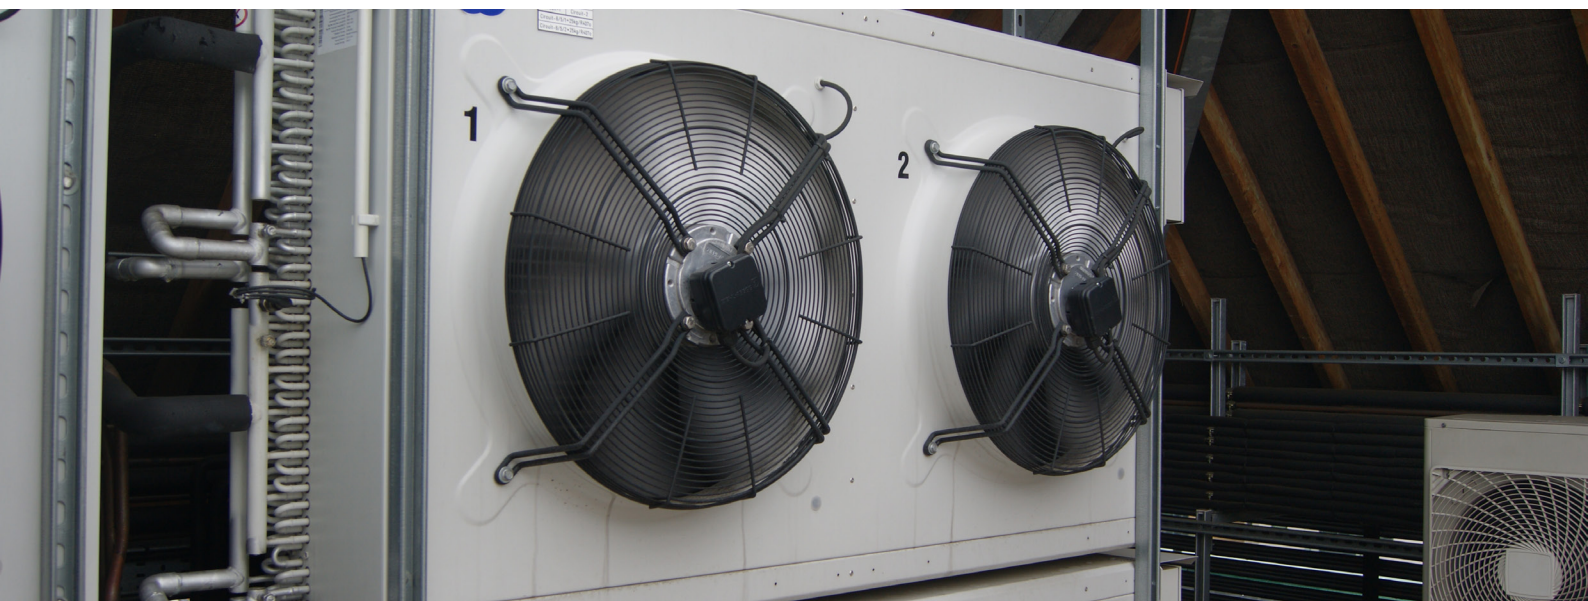
A regular client was having major problems with their condenser coils. They were severely scaled up and were tripping out on high pressure when the ambient temperature reached 21 degrees. They tried in vein to remove the scale themselves but eventually we were called in to assist and remove all scale as quickly as possible and without isolating the condenser.

Of course we were able to solve the problem and in under 4 hours using innovative cleaning techniques. You can clearly see from figure 1 & 2 to the right, that the airflow as measured by our anemometer was 118 on the heavily scaled area and on the cleaned area, where the scale had been removed the airflow reading was 874 averaging a 700% increase in airflow through the coil. This dramatically dropped the head pressure and the condenser breezed through the rest of the summer without any problems.
